Rochester Cathedral Quire Screen Conservation - Visit October 2017 -

QUIRE SCREEN PAINTED DECORATION AND FRAMED QUIRE SCREEN BOARDS

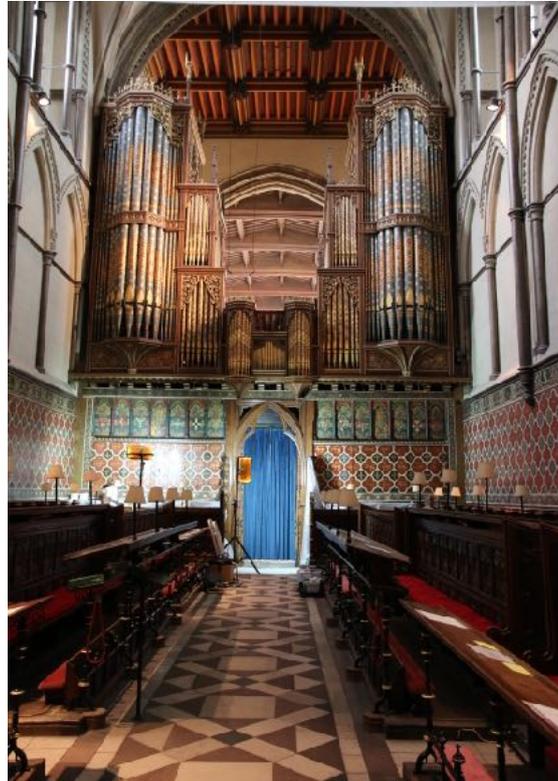
Picture 1 shows the quire screen at the back of the choir stalls. The part of the screen which was conserved was the areas to the immediate left and right of the entrance. The areas along the choir stalls were not part of the work done.

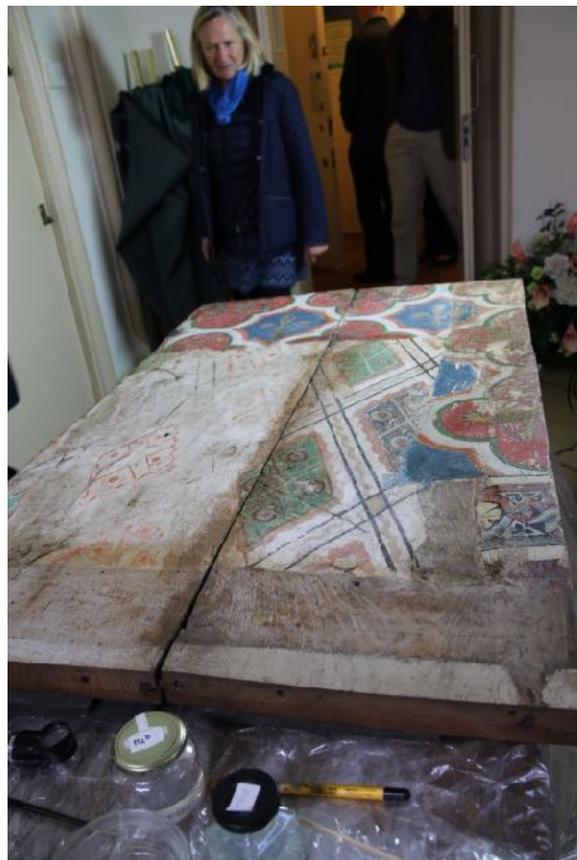
At that time two of the Quire screen boards - with both the 13th and 14th century paint schemes exposed - were detached, preserved in a frame and displayed on a pier in the South Quire Ambulatory. The 13th century decoration comprises a trellis pattern of double lines framing ornately decorated lozenges. The principal colours being bright-red, light-green, yellow ochre and black; all on a white ground.

Picture 2 shows the 13th Century decoration which was treated. These panels were to be replaced in a frame and were to be placed outside the Quire on display.

This complex layering of paint on the timber boards makes the Quire Screen decoration fragile and vulnerable to flaking and loss. The main purpose of the current conservation treatment - to both the Quire Screen decoration and the framed boards - is to re-attach localised areas of flaking paint. The treatment involves injecting a weak solution of conservation grade adhesive behind each flake. The lifted paint is then eased back into place using a heated spatula. The heat serving to relax and flatten the distorted flakes and encourage the adhesive to become tacky.”

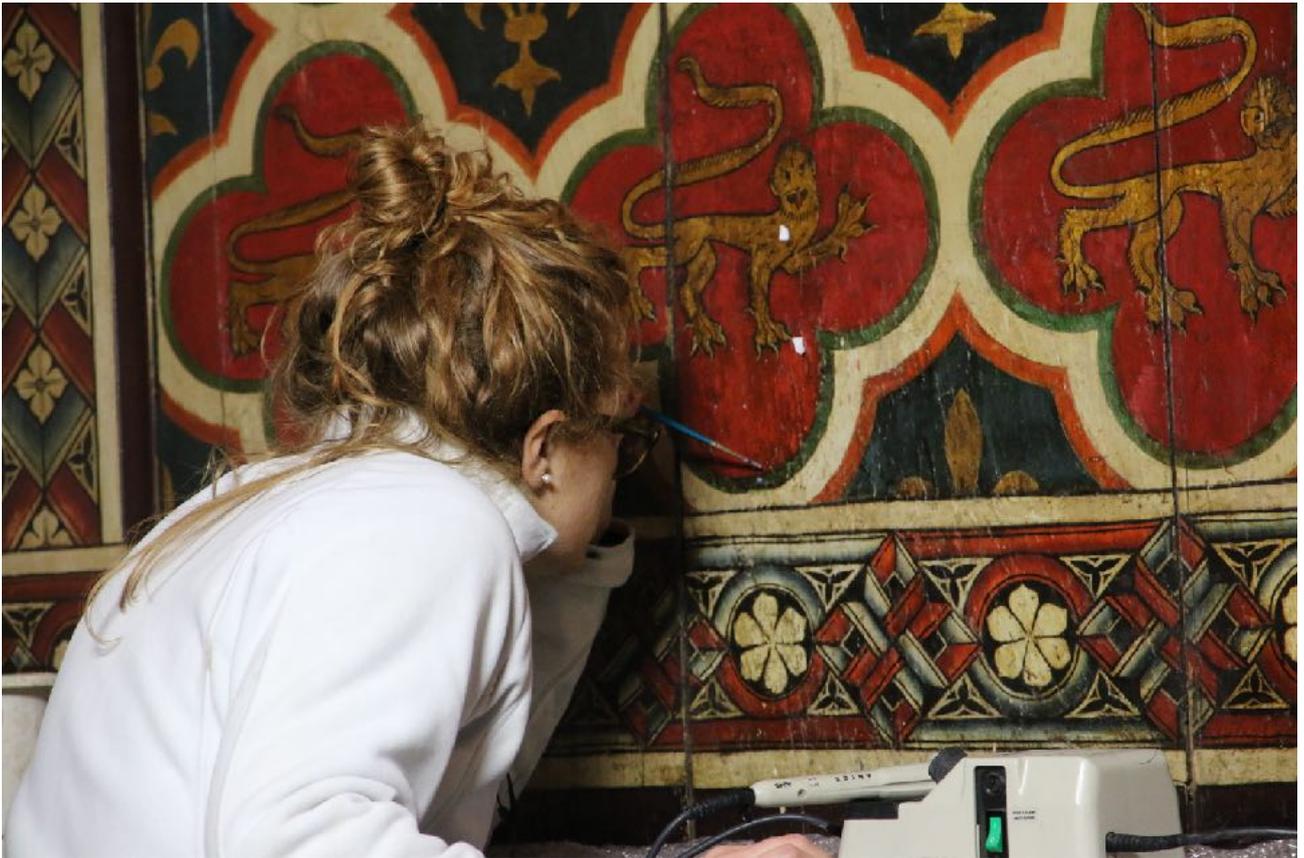
Picture 3 shows one of the conservators at work whilst Picture 4 shows a part of the screen yet to be worked on.

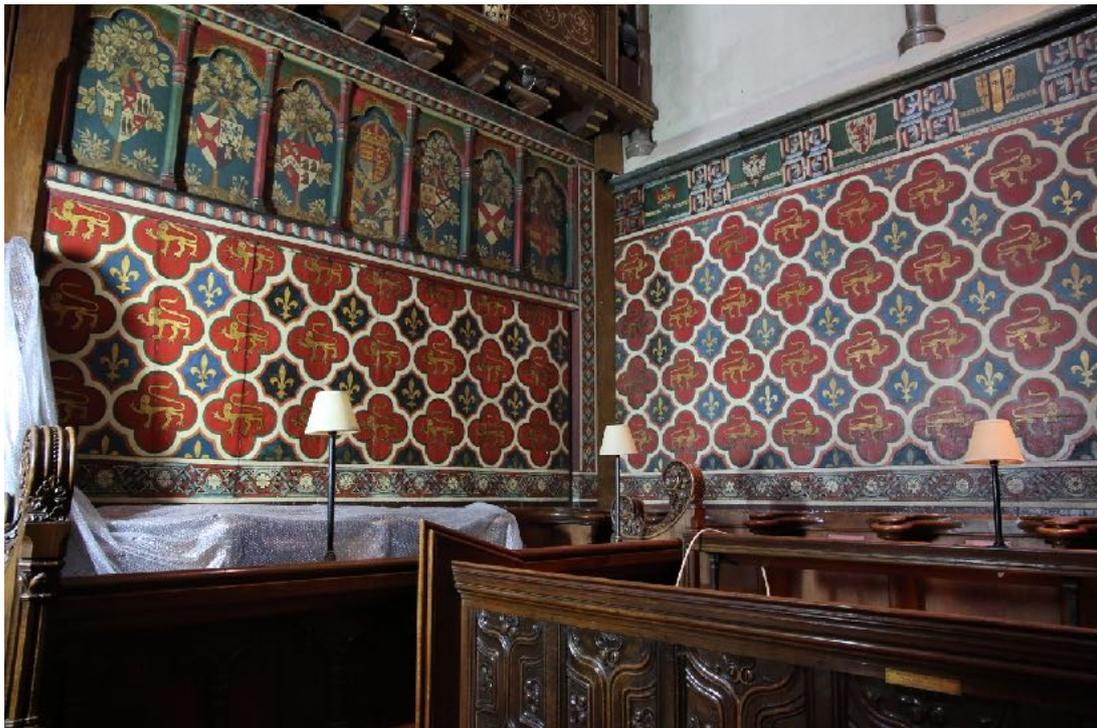
Picture 5 shows the finished screen on the right of the entrance.
